FUJITSU GENERAL AMERICA, INC

SERVICE BULLETIN

Number: 0041
Date: 1/05/2018
TYPE: Field

ARU / AUU Models Communication error E11 code

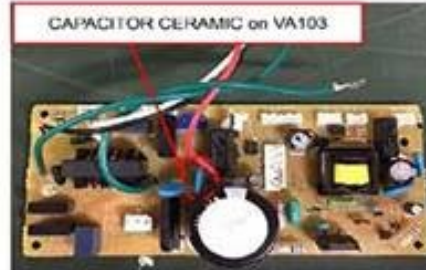
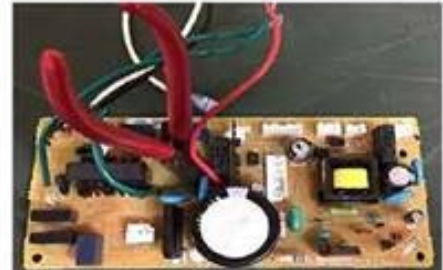
Part# K9707398243
Part# K9707398236

Objective: During production of the above mentioned models an incorrect valued capacitor was installed on the main power pcb which causes a communication error code. The communication error code of 00:11 – Er is generated which appears on the wired remote control units. The blink pattern is 1 x operation (green) and 1x timer (red). If this failure appears and all general troubleshooting has been performed, please remove the main power supply from the indoor unit and carefully remove / cut-away the light blue capacitor labeled VA103.

Power supplies affected

(1) Remove CAPACITOR CERAMIC on VA103

ⓄBe careful of the order to remove

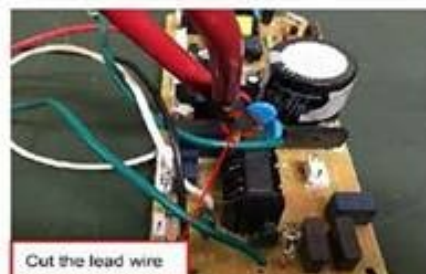
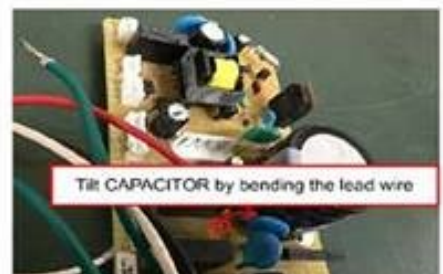
Affected component

ⓄBe careful of the order to remove
