## EJ2U Error Code – Branch Box Error

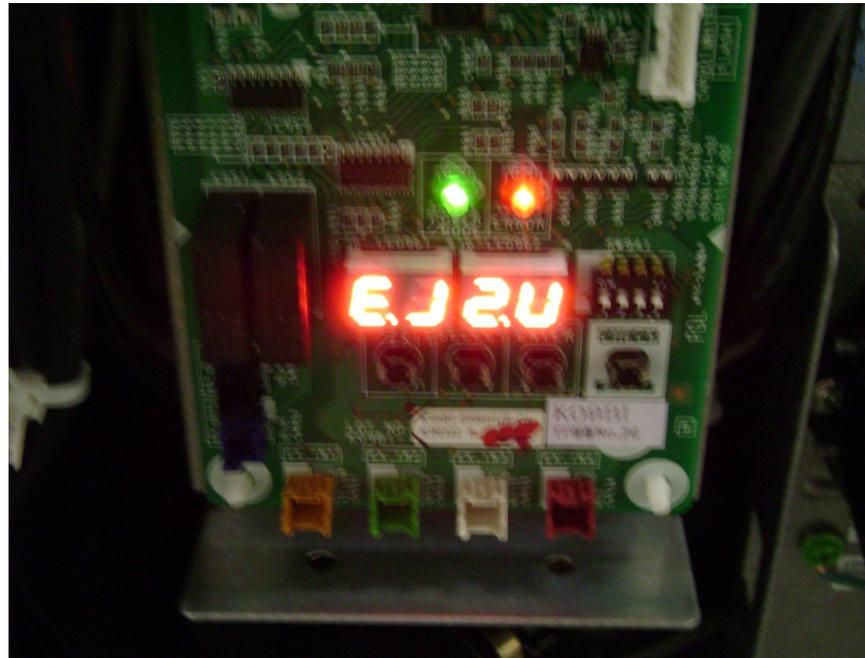
To begin, inspect all branch boxes for anything other than a solid green LED on LED402. With the *EJ2U* error code, it is not uncommon to see the following error codes registered on the effected branch box:

- LED402 – 1x Timer
- LED402 – 2x Timer
- LED402 – 6x Timer
- LED402 – 7x Timer
- LED402 – 8x Timer
- LED402 – 9x Timer

Look for the branch box displaying any one of the above mentioned error codes as that would be the defective branch box.

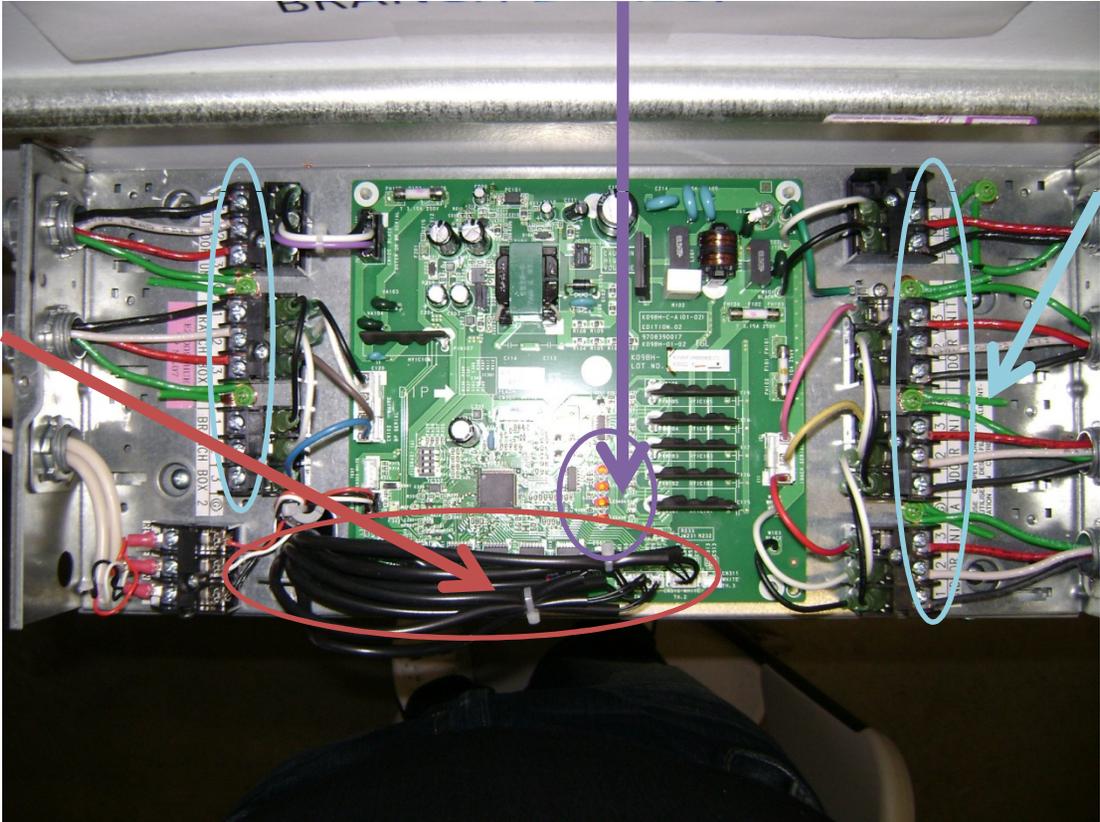
With so many wires going in and out of the branch boxes, it is very possible to mismatch the wires to their corresponding evaporators. Confirm all terminals for crossed wires.

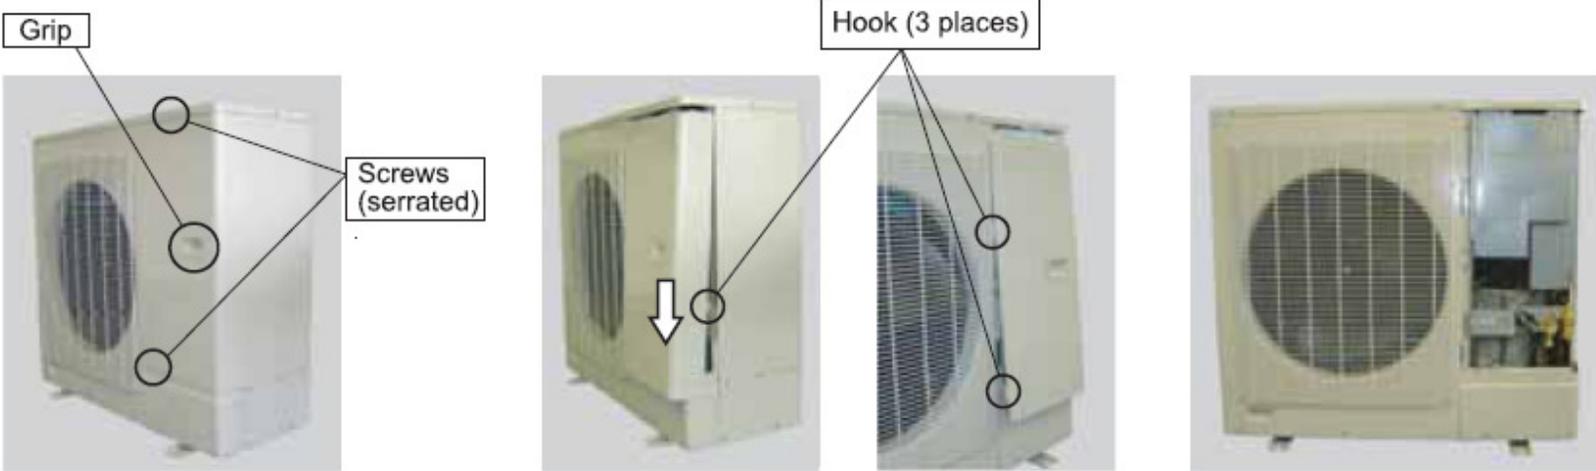
The first image shows the outdoor AC unit with three callouts: 'Grip' pointing to the top edge, 'Screws (serrated)' pointing to two screws on the side, and 'Hook (3 places)' pointing to three hooks on the top edge. The second image shows the service panel being slid down, with a white arrow pointing downwards and 'Hook (3 places)' pointing to the top edge. The third image shows the service panel removed, revealing the internal components.

Remove the 2 mounting screws.

Remove the SERVICE PANEL by sliding downward.

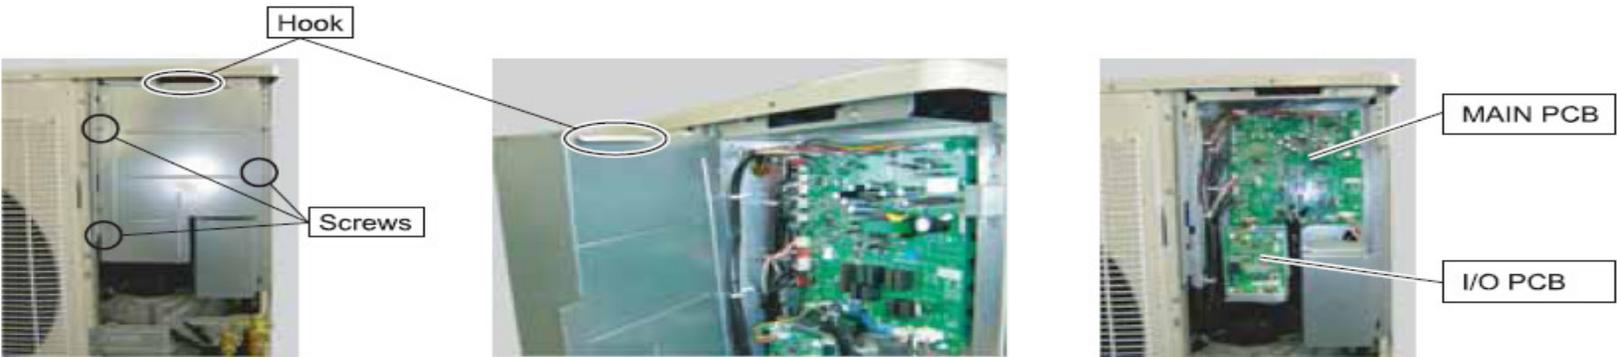
The first image shows the front cover being slid towards the left, with callouts for 'Hook' at the top and 'Screws' at the bottom. The second image shows the front cover removed, with a callout for 'Hook' at the top edge. The third image shows the internal components, with callouts for 'MAIN PCB' and 'I/O PCB'.

Remove the 3 mounting screws.  
Remove the COVER(FRONT) by sliding toward.
